# **319(H) GRANT (WQR-2019-LHC00130) DESIGN AND IMPLEMENTATION OF FOUR SMALL-SCALE IN-LAKE / WATERSHED PROJECTS LAKE HOPTCONG, SUSSEX AND MORIS COUNTIES, NEW JERSEY**

Funded By:  
New Jersey Department of Environmental Protection  
319(H) NPS Program

**MAY 2025**

PRINCETON HYDRO, LLC  
35 CLARK STREET, SUITE 200  
TRENTON, NJ 08611  
908-237-5660

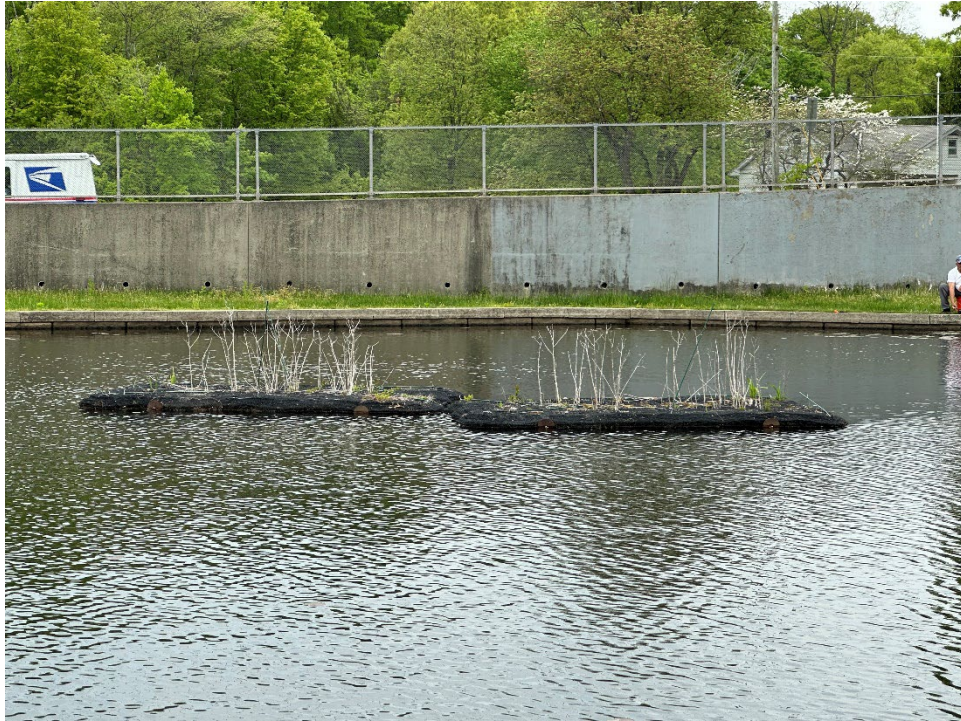
On 18 June 2024, the islands were removed from their place in the water and re-planted with native wetland plants (Table 2.2). Due to a combination of the hot and dry summer of 2022 and the failing of the netting, most of the plants did not survive into 2024. However, there were funds in the grant for additional plants, and it was decided to replant all of the FWIs. After planting the bird netting was replaced and the FWIs deployed back into the channel. The netting was reinforced with sturdier stakes to prevent the failing of the nets. Additionally, three layers of twine were wrapped around each island to act as a secondary barrier to prevent waterfowl from landing on the islands. Finally, mylar tape was added to the netting of each island to act as an additional deterrent to waterfowl.

**Photo 2.3: FWIs in Landing Channel before replanting in 2024**

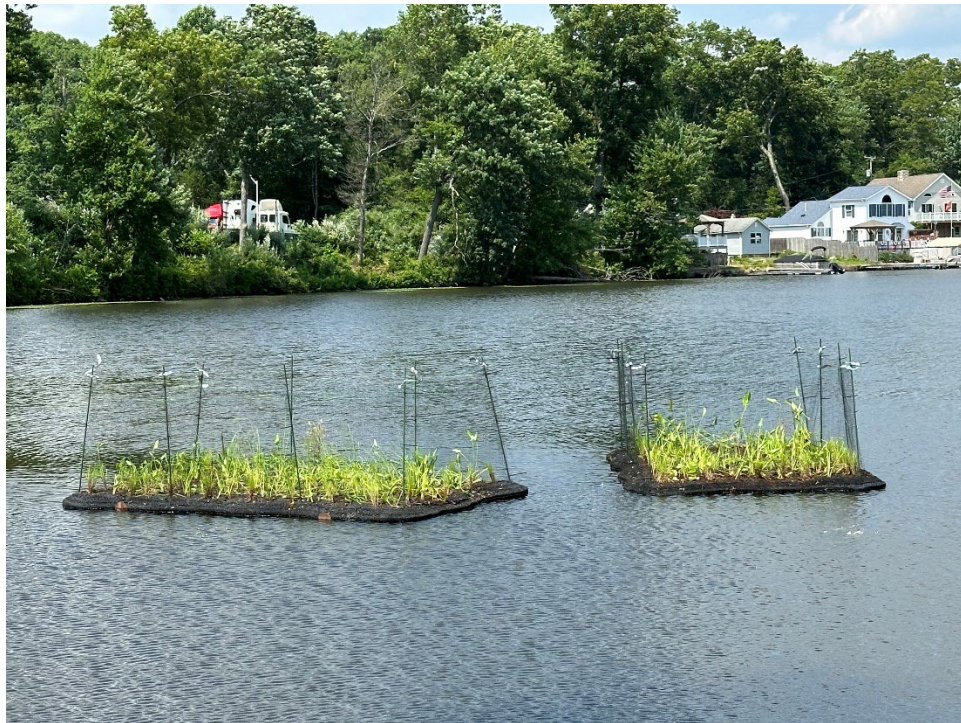
**Photo 2.4: FWIs installed in Landing Channel after the 2024 Replanting**

There have been repeated instances of geese knocking down the fencing on FWIs installed in Lake Hopatcong over the years, even after sturdier materials have been used. Unless there are local volunteers available to monitor and address fencing issues at a high frequency during the first two years post-installation, it is not recommended to install additional FWIs in Lake Hopatcong.

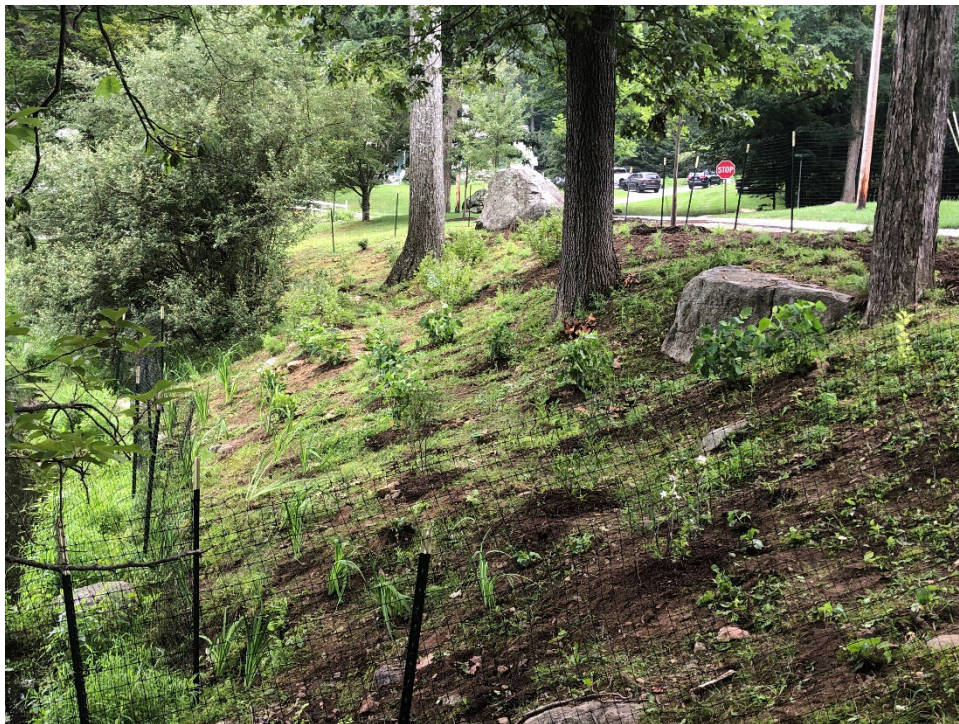
**Photo 3.1: Southwest shoreline of Memorial Pond in July 2023**

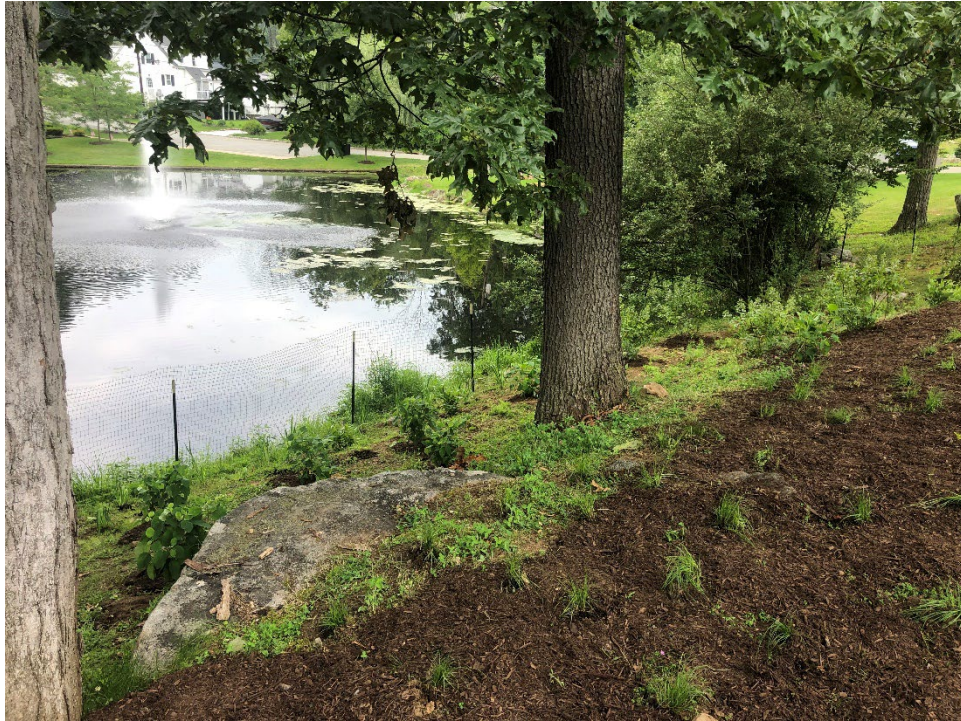
**Photo 3.2: Shoreline of Memorial Pond plantings in July 2023**

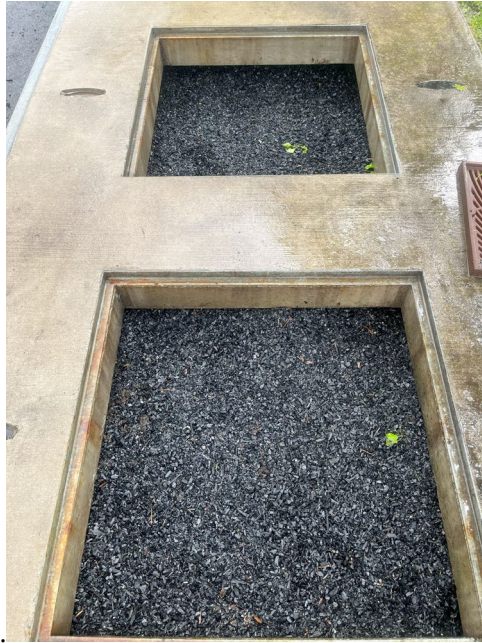
**Photo 4.1: Completed biochar installation in a Filterra unit in May 2023**

In conclusion, Princeton Hydro recommends the continued use of Biochar in stormwater structures for the phosphorus removal capability that it offers. The added value of the Biochar is that it can remove measurable amounts of SRP, which is the dissolved form of phosphorus that is easily assimilated by algae and cyanobacteria. However, Princeton Hydro also recommends installing Biochar socks in stormwater structures rather than loose Biochar, as loose Biochar can be transported out of the devices during flooding events. Additionally, the Biochar socks are easier to install and remove than loose Biochar.

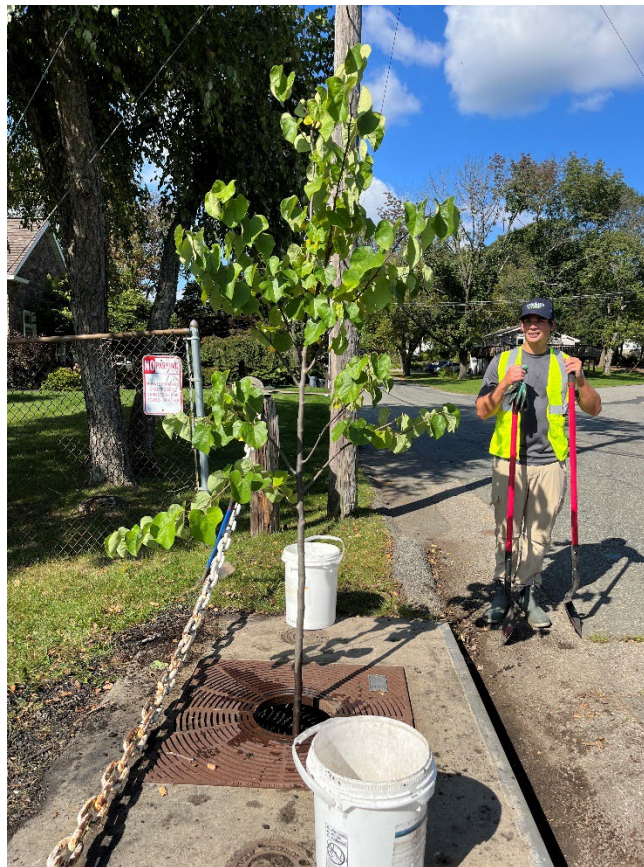
**Photo 4.2: Completed tree planting in a Filterra unit in October 2023**

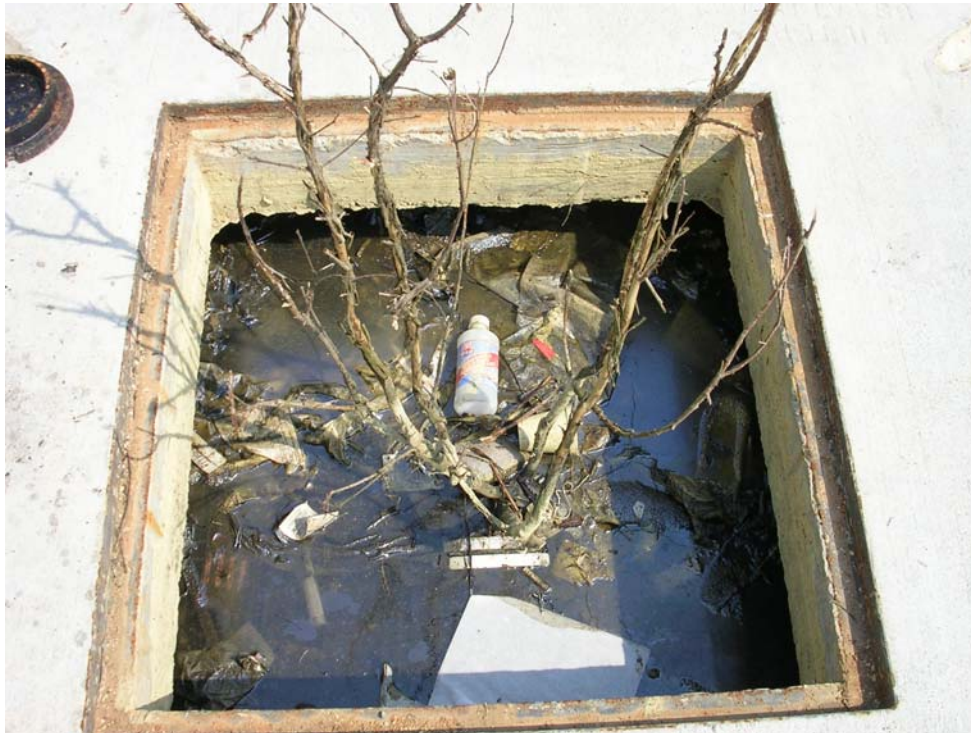
*This picture shows the inside of a unit that has been neglected for several years. Filterra units are like all other stormwater BMP's and require regular maintenance to ensure they continue to operate efficiently.*

Unfortunately, there are units installed throughout the country that have been neglected after the standard 1-year maintenance period, in which Filterra provides, has expired. Depending on existing site conditions, these units may not be operating to full potential. Some units may simply need a standard maintenance session to bring it back to full operation while other may require additional attention. This section is designed to assist you in addressing a neglected Filterra unit. If you have any questions, please call our office for assistance
