# **319(H) GRANT (WQR-2019-LHC00130) DESIGN AND IMPLEMENTATION OF FOUR SMALL-SCALE IN-LAKE / WATERSHED PROJECTS LAKE HOPTCONG, SUSSEX AND MORIS COUNTIES, NEW JERSEY**

Funded By:  
New Jersey Department of Environmental Protection  
319(H) NPS Program

**MAY 2025**

PRINCETON HYDRO, LLC  
35 CLARK STREET, SUITE 200  
TRENTON, NJ 08611  
908-237-5660

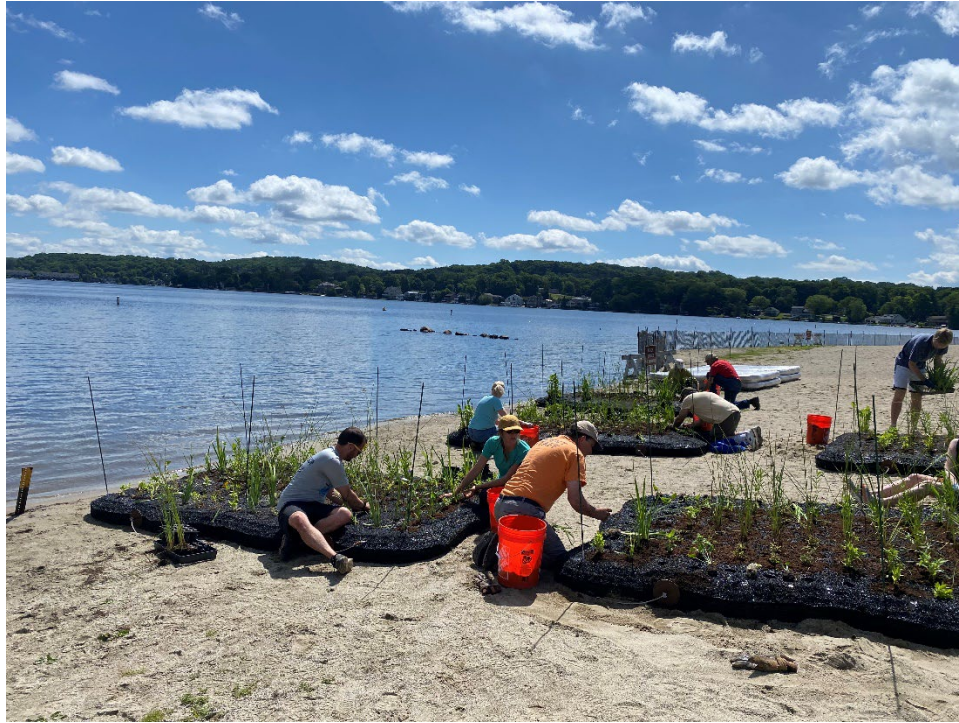
**Photo 2.1: Volunteers and Princeton Hydro planting FWIs in 2022**

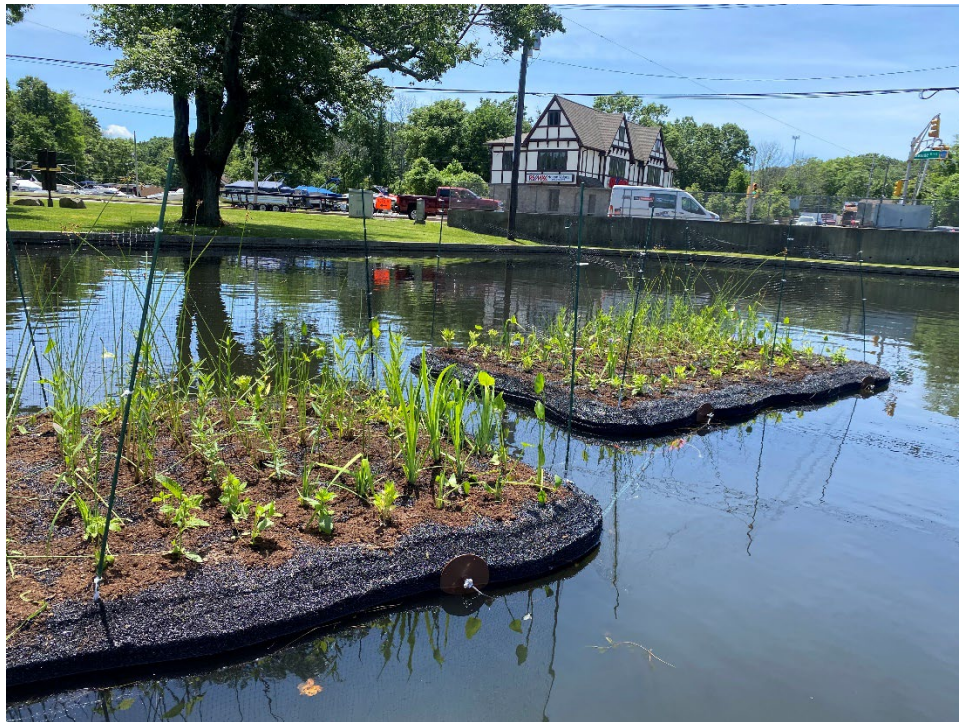
**Photo 2.2: Finished FWIs installed in Landing Channel in 2022**

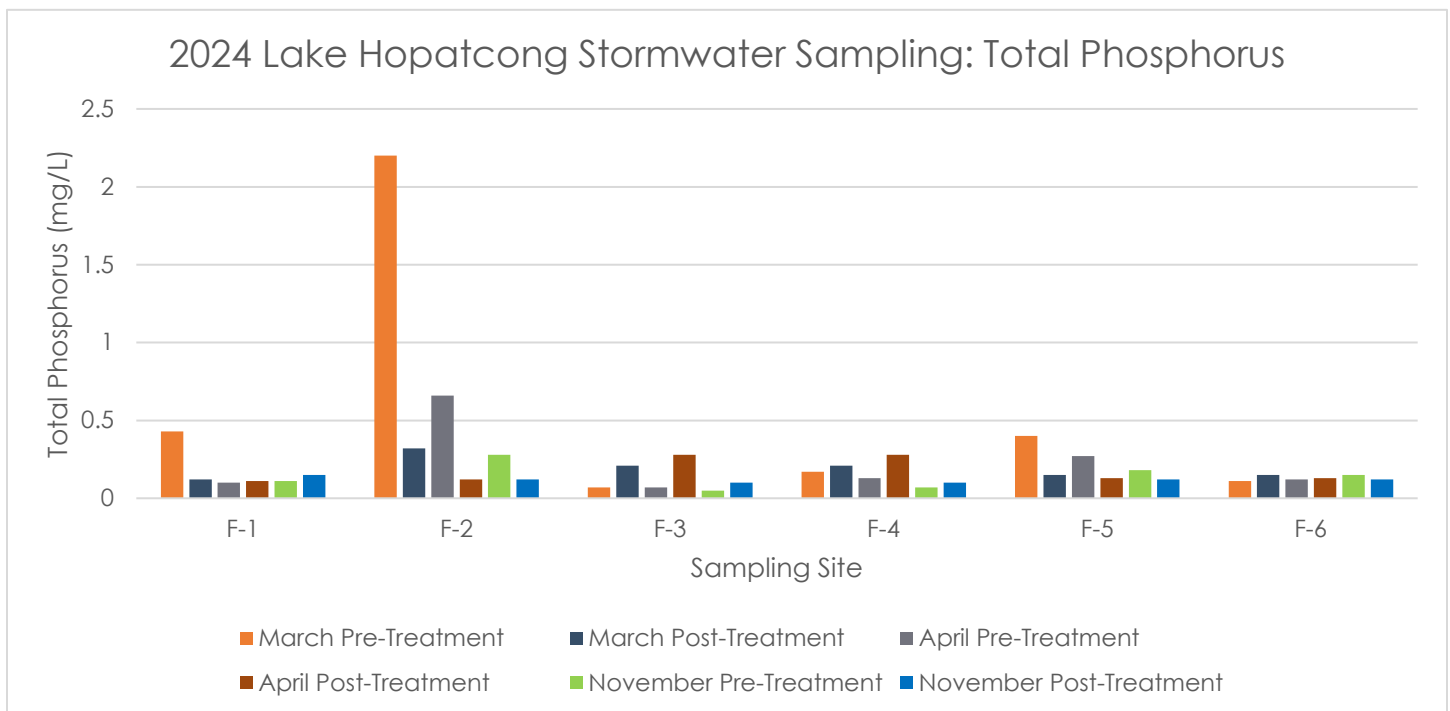
Figures 4.1 – 4.3 present the pre- and post-treatment pollutant concentrations for each sampling event. TP concentrations were elevated pre- and post-treatment during each sampling event; however, the mean removal rates of 75% and 49% at F-2 and F-5 are significant. F-1, which had the trees replaced, had a 9% TP removal rate while F-6 had a slight increase of 8%. Data from F-3 and F-4 will not be analyzed. Overall, TP removal rates were positive at F-1, F-2, F-5, and F-6.

**Figure 4.1: TP concentrations pre and post-treatment during the 2024 storm events**

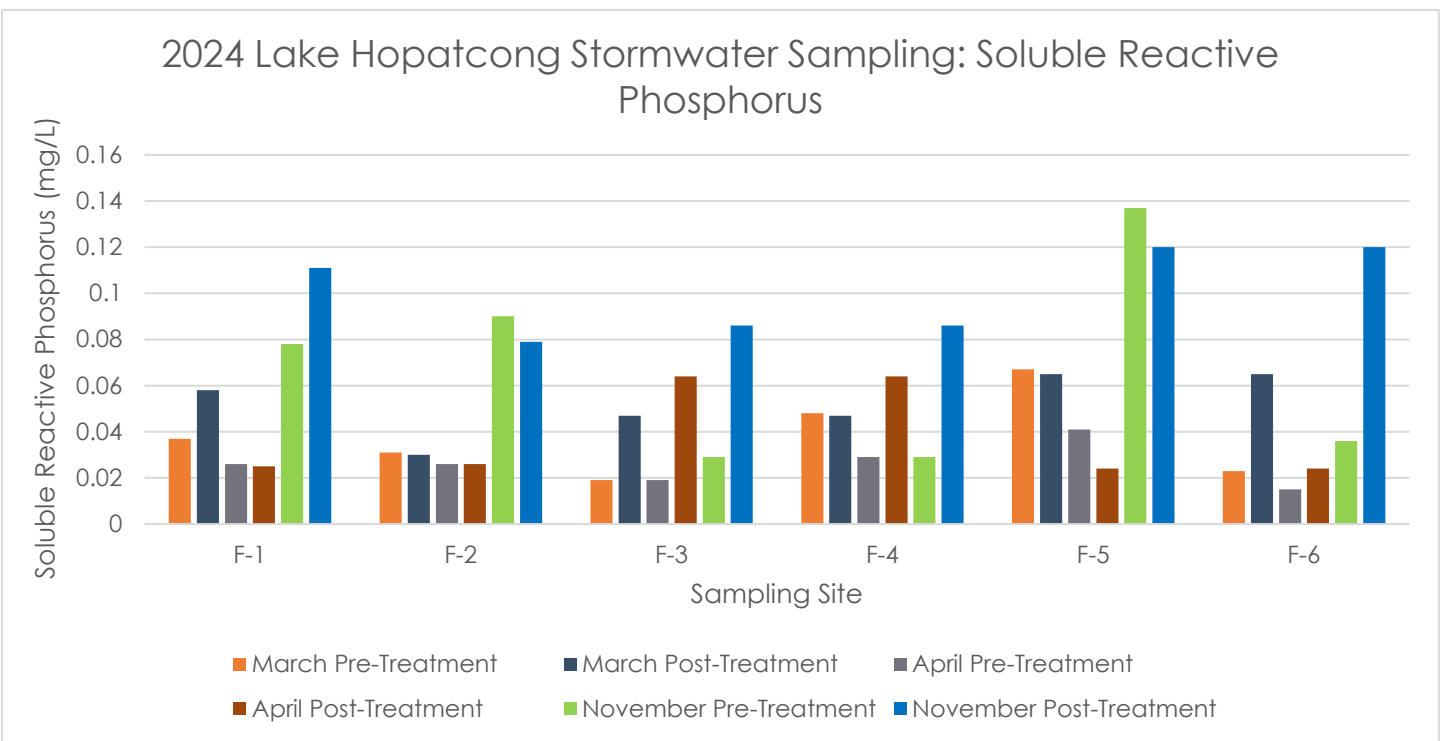
SRP removal rates were poor at most sites; however, the highest removal rate was measured at F-5 (19%). This indicates that Biochar may have the potential to enhance SRP removal rates relative to standard filter media.

**Figure 4.2: SRP concentrations pre and post-treatment during the 2024 storm events**

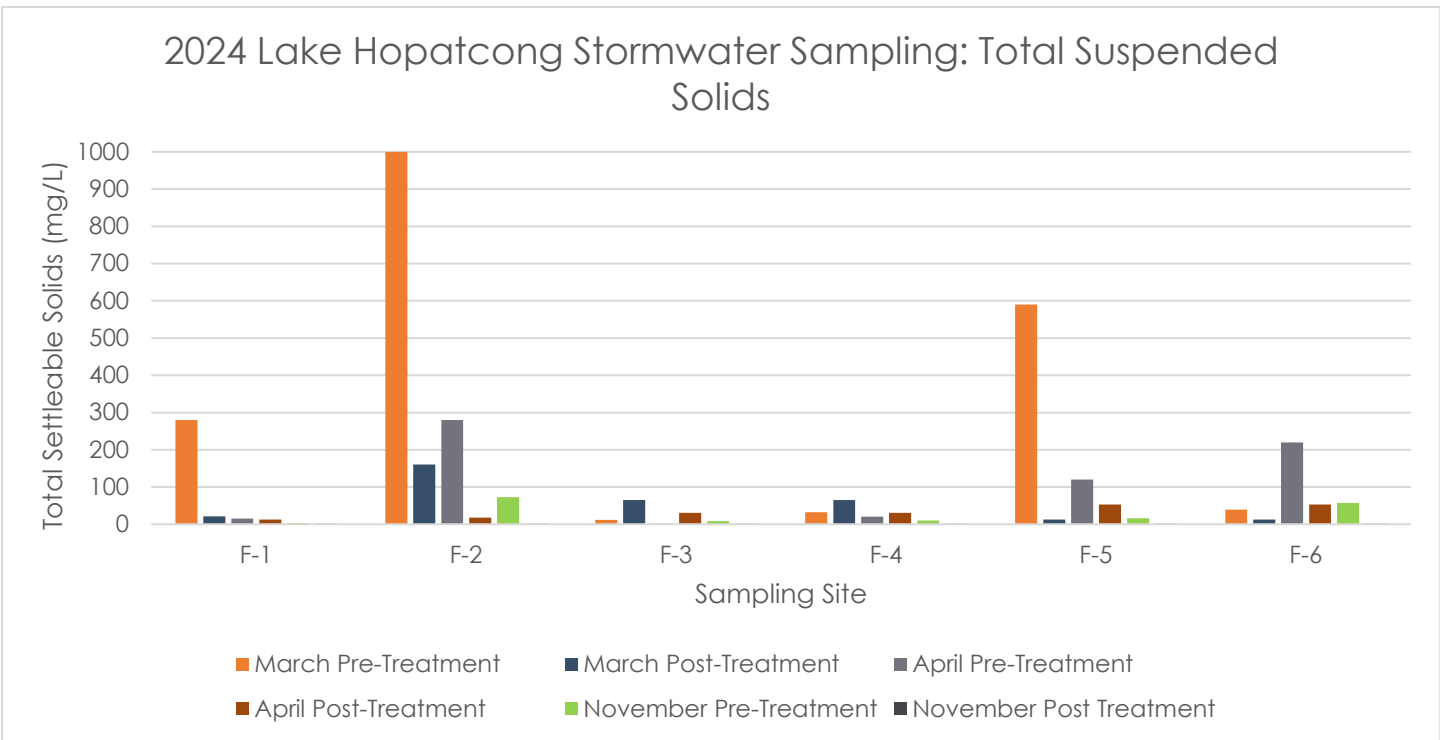
TSS removal rates were significant at all sites except for F-3 and F-4, which were the two Filterras that had post-treatment water influenced by unfiltered stormwater. TSS removal rates varied between 58% and 92% at the three Filterras that had the trees replaced, and a removal rate of 82% at F-5, the Filterra with Biochar. Not only were TSS removal rates very high, but the pre-treatment concentrations were often elevated, indicating that all Filterra units, regardless of filter media, were very effective in reducing TSS concentrations.

**Figure 4.3: TSS concentrations pre and post-treatment during the 2024 storm events**

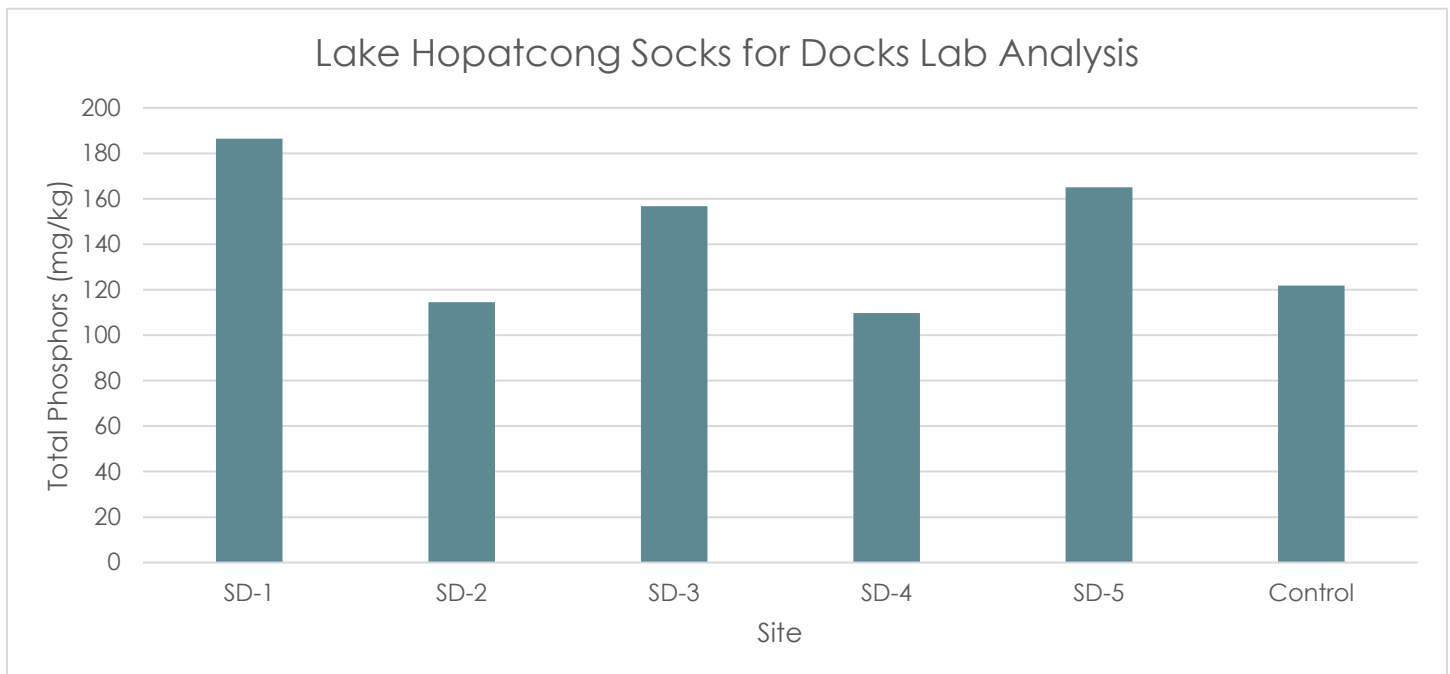
The control sock had a TP concentration of 122 mg/kg and an extractable phosphorus concentration of 160 µg/L. For context, it was known that the control sock would have measurable concentrations of phosphorus because it is comprised of organic material. The average TP concentration in the Biochar socks that were deployed in Lake Hopatcong is 147 mg/kg. Thus, the Biochar socks that were deployed in the lake removed approximately 25 mg/kg TP, relative to the control sock. When accounting for the total mass of each of the 470 Biochar socks, the lab data indicates that approximately 0.14 lbs of phosphorus were removed from the lake.

**Figure 5.1: Total phosphorus concentrations in Biochar**

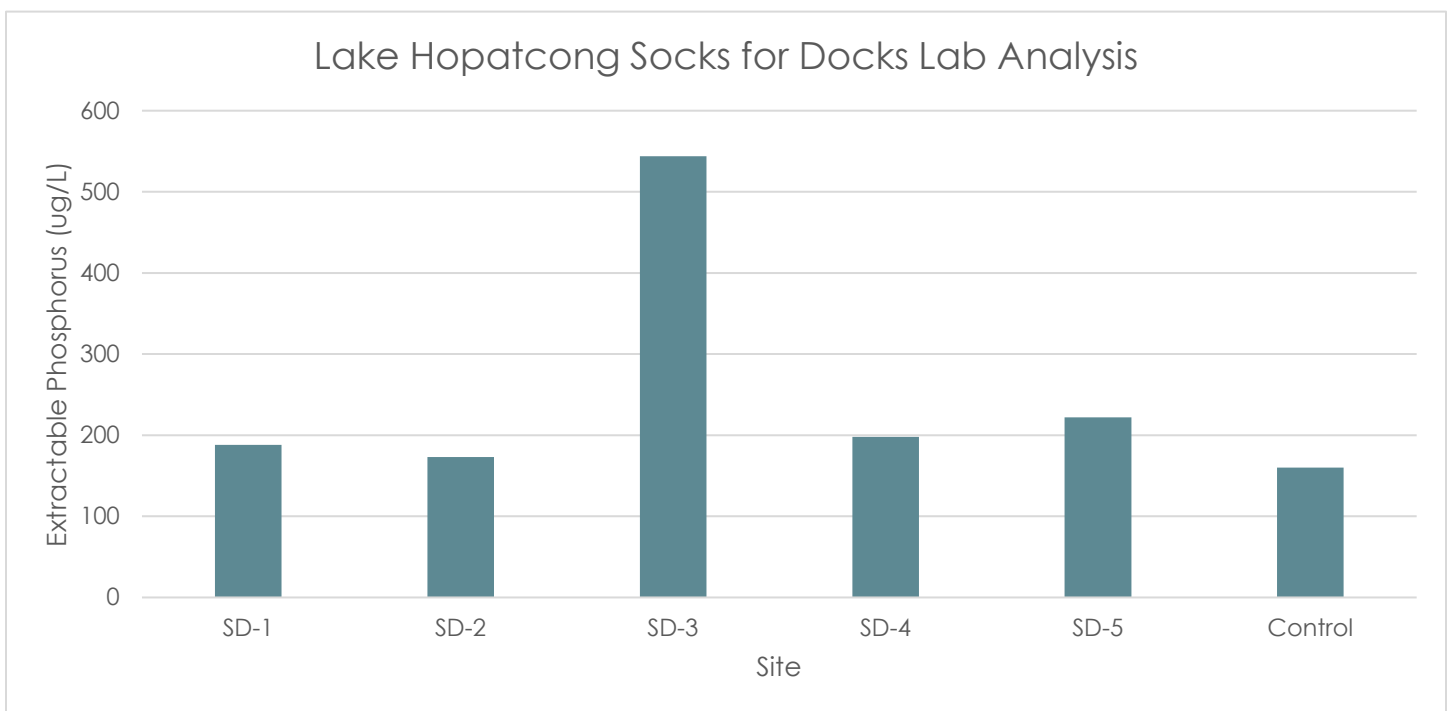
All of the socks that were deployed in the lake had a higher extractable phosphorus concentration than the control sock; however, the increases in socks SD-1, SD-2, SD-4, and SD-5 were minimal, averaging only 35 µg/L higher. When considering the TP concentration in each stock, the amount of extractable phosphorus is extremely low. SD-3 had an extractable phosphorus concentration 384 µg/L higher than the control sock, but even this is very low relative to the TP concentration.

**Figure 5.2: Extractable phosphorus concentrations in Biochar**
